**Flood Control Project Maintenance**  
**2019 Structure Summary Report**  
**Overall Unit and Item Ratings**

## DWR Sutter Maintenance Yard

### Butte Slough Drainage Structure

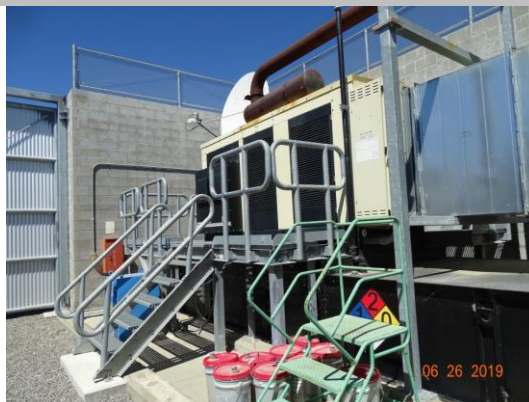
Photo 1 of 1 : ST\_2019\_NA0060\_21\_8\_20190626\_00030.jpg

LM Start	0.00	Rating **	A	Issue No.	8	
LM End	0.00	Issue Type +	Ma	Location *		
Category	Pump Stations			GPS Latitude/Longitude		
				Start	End	
Item	Power			38.931815 °	38.931815 °	
				-121.634331 °	-121.634331 °	
DWR ID	DWR_NA0060_21_t_2012_8					
Action/Comments						
Inspector Comments: The structure is on the grid with emergency backup generator.

View of backup generator inside the facility (Summer 2019).

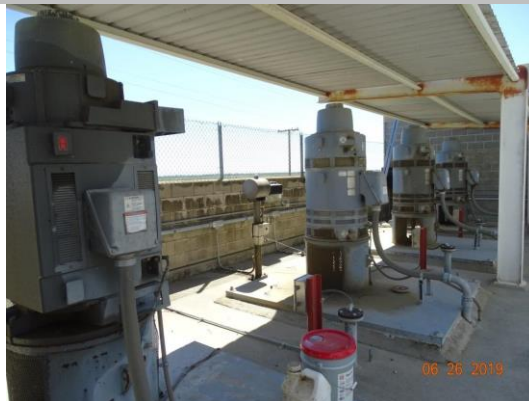
Photo 1 of 2 : ST\_2019\_NA0060\_21\_10\_20190626\_00031.jpg

LM Start	0.00	Rating **	A	Issue No.	10
LM End	0.00	Issue Type +	Ma	Location *	
Category	Pump Stations			GPS Latitude/Longitude	
				Start	End
Item	Motors, Engines, Fans & Gear Reducers			38.931815°	38.931815°
				-121.634331°	-121.634331°
DWR ID	DWR_NA0060_21_t_2012_10				
Action/Comments					
Inspector Comments: These items appear to be maintained and in operating condition.

View of pump motors (Summer 2019).

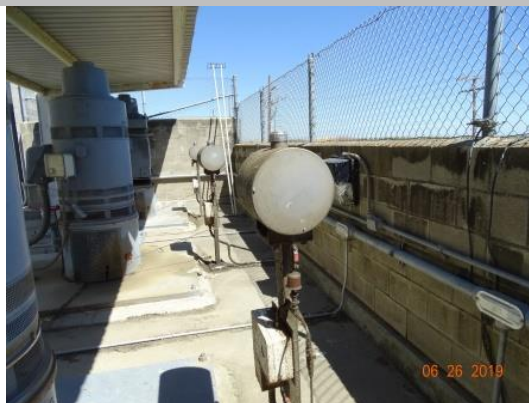
Photo 2 of 2 : ST\_2019\_NA0060\_21\_10\_20190627\_00046.jpg

View of pump oil well (Summer 2019).

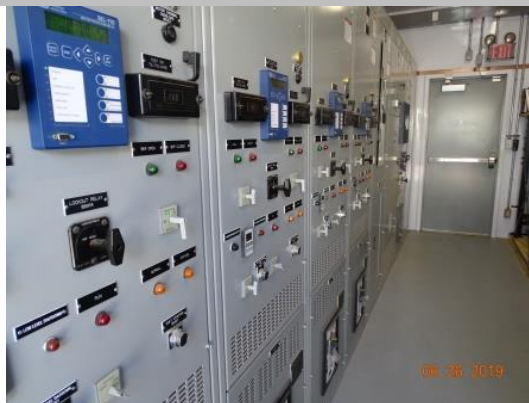
Photo 1 of 1 : ST\_2019\_NA0060\_21\_11\_20190627\_00047.jpg

LM Start	0.00	Rating **	A	Issue No.	11
LM End	0.00	Issue Type +	Ma	Location *	
Category	Pump Stations			GPS Latitude/Longitude	
				Start	End
Item	Pump Control Systems			38.931815°	38.931815°
				-121.634331°	-121.634331°
DWR ID	DWR_NA0060_21_t_2012_11				
Action/Comments					
Inspector Comments: Pump control systems on site are new and appear to be in working order.

View of pump control panels inside operating room (Summer 2019).

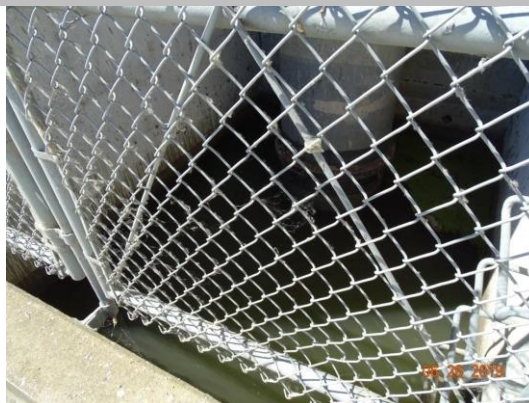
Photo 1 of 1 : ST\_2019\_NA0060\_21\_12\_20190626\_00034.jpg

LM Start	0.00	Rating **	A	Issue No.	12
LM End	0.00	Issue Type +	Ma	Location *	
Category	Pump Stations			GPS Latitude/Longitude	
				Start	End
Item	Sumps/Wet Well			38.931815 °	38.931815 °
				-121.634331 °	-121.634331 °
DWR ID	DWR_NA0060_21_t_2012_12				
Action/Comments					
Inspector Comments: Sumps are clear and free of debris.

View of one of the wet wells. All four wet wells looked like this (Summer 2019).

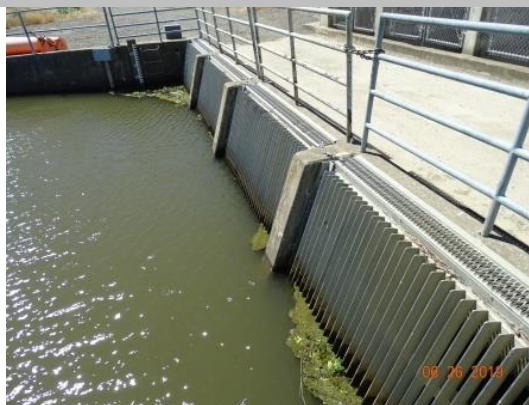
Photo 1 of 1 : ST\_2019\_NA0060\_21\_13\_20190627\_00048.jpg

LM Start	0.00	Rating **	A	Issue No.	13
LM End	0.00	Issue Type +	Ma	Location *	
Category	Pump Stations			GPS Latitude/Longitude	
				Start	End
Item	Trash Racks			38.931815 °	38.931815 °
				-121.634331 °	-121.634331 °
DWR ID	DWR_NA0060_21_t _ 2012_13				
Action/Comments					
Inspector Comments: No debris present on trash racks, they appear to be in good condition.

View of trash racks (Summer 2019).

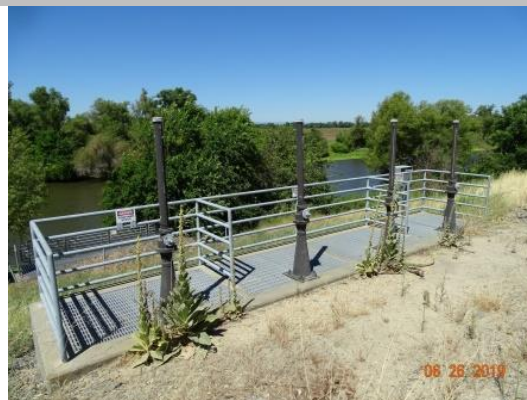
Photo 1 of 1 : ST\_2019\_NA0060\_21\_17\_20190627\_00049.jpg

LM Start	0.00	Rating **	A	Issue No.	17	
LM End	0.00	Issue Type +	Ma	Location *		
Category	Pump Stations			GPS Latitude/Longitude		
				Start	End	
Item	Manual Gate Operators			38.931815 °	38.931815 °	
				-121.634331 °	-121.634331 °	
DWR ID	DWR_NA0060_21_t_2012_17					
Action/Comments						
Inspector Comments: Manual gate operators appear to be in good condition.

View of manual gate operators (Summer 2019).

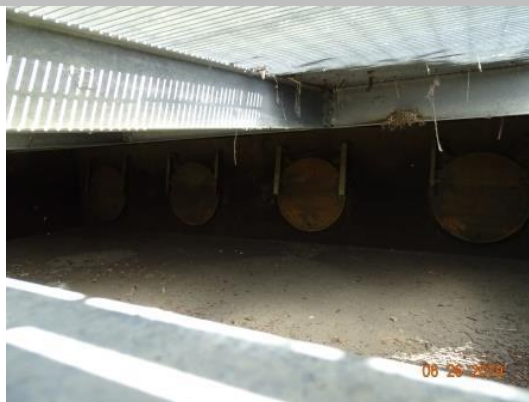
Photo 1 of 1 : ST\_2019\_NA0060\_21\_19\_20190627\_00050.jpg

LM Start	0.00	Rating **	A	Issue No.	19
LM End	0.00	Issue Type +	Ma	Location *	
Category	Pump Stations			GPS Latitude/Longitude	
				Start	End
Item	Flap Gates			38.931815 °	38.931815 °
				-121.634331 °	-121.634331 °
DWR ID	DWR_NA0060_21_t_2012_19				
Action/Comments					
Inspector Comments: Flap gates appear to be in working condition. There are no apparent signs of significant corrosion or damage. All are closed.

View of closed flap gates (Summer 2019).

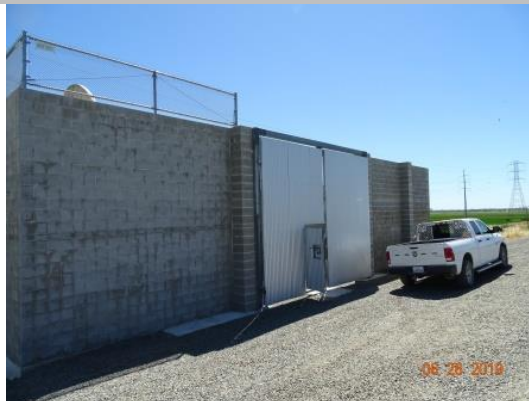
Photo 1 of 1 : ST\_2019\_NA0060\_21\_21\_20190627\_00051.jpg

LM Start	0.00	Rating **	A	Issue No.	21
LM End	0.00	Issue Type +	Ma	Location *	
Category	Pump Stations			GPS Latitude/Longitude	
				Start	End
Item	Security Fencing			38.931815 °	38.931815 °
				-121.634331 °	-121.634331 °
DWR ID	DWR_NA0060_21_t_2012_21				
Action/Comments					
Inspector Comments: Site is secured by a masonry brick wall and steel gate.

View of concrete security fence with additional chainlink fence, and steel security door (Summer 2019).

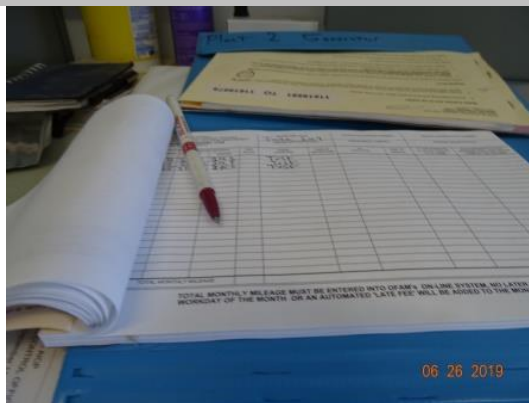
Photo 1 of 1 : ST\_2019\_NA0060\_22\_1\_20190627\_00044.jpg

LM Start	0.00	Rating **	A	Issue No.	1	
LM End	0.00	Issue Type +	Ma	Location *		
Category	Pump Stations			GPS Latitude/Longitude		
				Start	End	
Item	Operating Log			39.026449 °	39.026449 °	
				-121.726937 °	-121.726937 °	
DWR ID	DWR_NA0060_22_t_2012_1					
Action/Comments						
Inspector Comments: Operation log is located at the site.

View of operating log (Summer 2019).

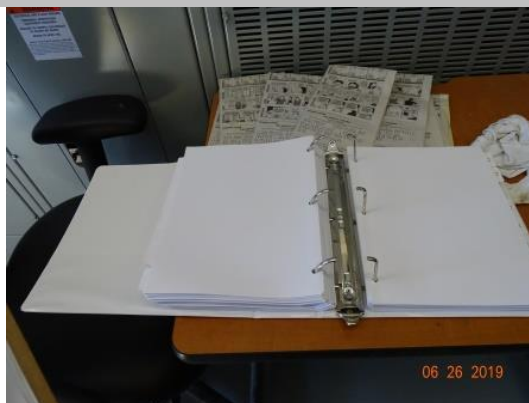
Photo 1 of 1 : ST\_2019\_NA0060\_22\_2\_20190627\_00045.jpg

LM Start	0.00	Rating **	A	Issue No.	2
LM End	0.00	Issue Type +	Ma	Location *	
Category	Pump Stations			GPS Latitude/Longitude	
				Start	End
Item	Operation & Maintenance Manual			39.026449 °	39.026449 °
				-121.726937 °	-121.726937 °
DWR ID	DWR_NA0060_22_t_2012_2				
Action/Comments					
Inspector Comments: O&M Manual is present at the site. Sutter Maintenance Yard will provide documentation of maintenance going forward.

View of O&amp;M Manual (Summer 2019).

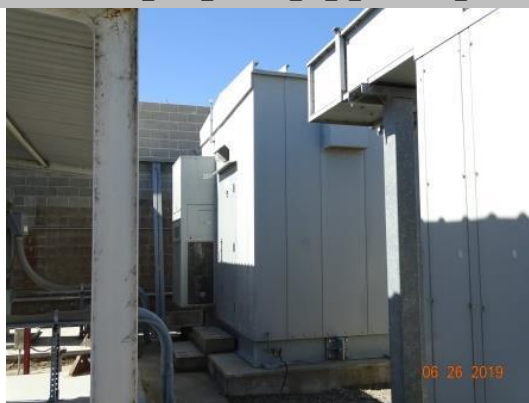
Photo 1 of 2 : ST\_2019\_NA0060\_22\_3\_20190627\_00046.jpg

LM Start	0.00	Rating **	A	Issue No.	3
LM End	0.00	Issue Type +	Ma	Location *	
Category	Pump Stations			GPS Latitude/Longitude	
				Start	End
Item	Plant Building			39.026449 °	39.026449 °
				-121.726937 °	-121.726937 °
DWR ID	DWR_NA0060_22_t_2012_3				
Action/Comments					
Inspector Comments: Plant building appears to be in working order.

View of outside of pump operating building (Summer 2019).

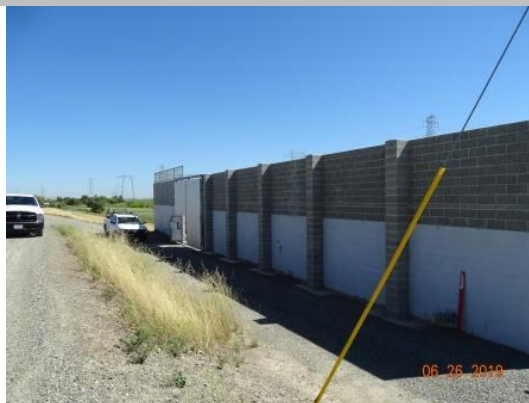
Photo 2 of 2 : ST\_2019\_NA0060\_22\_3\_20190627\_00047.jpg

View of outside of facility (Summer 2019).

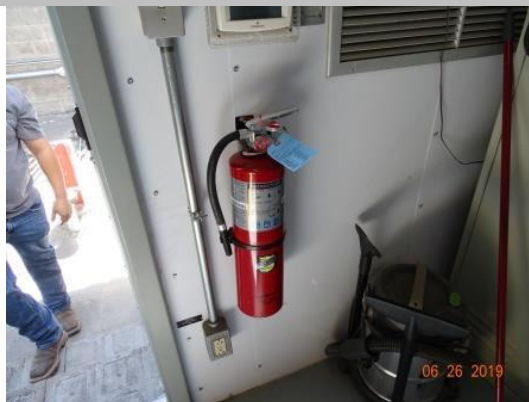
Photo 1 of 7 : ST\_2019\_NA0060\_22\_5\_20190627\_00048.jpg

LM Start	0.00	Rating **	A	Issue No.	5
LM End	0.00	Issue Type +	Ma	Location *	
Category	Pump Stations			GPS Latitude/Longitude	
				Start	End
Item	Safety			39.026449 °	39.026449 °
				-121.726937 °	-121.726937 °
DWR ID	DWR_NA0060_22_t_2019_5				
Action/Comments					
Inspector Comments: The site has fire extinguishers on site and fall protection rails. Gates have been installed to limit access to pump inlet. Railings above trash racks are in the process of installation.

View of fire extinguisher inside operating building (Summer 2019).

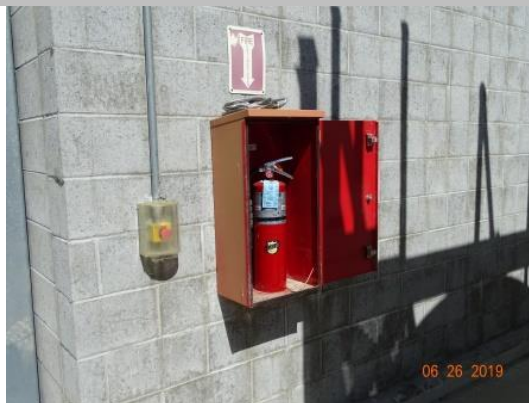
Photo 2 of 7 : ST\_2019\_NA0060\_22\_5\_20190627\_00049.jpg

View of fire extinguisher next to facility entrance (Summer 2019).

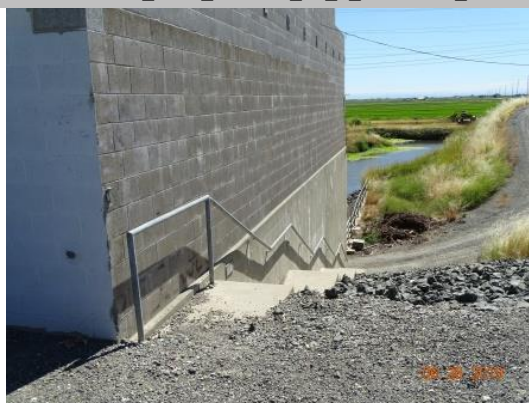
Photo 3 of 7 : ST\_2019\_NA0060\_22\_5\_20190627\_00050.jpg

View of stair railing down to pump inlet (Summer 2019).

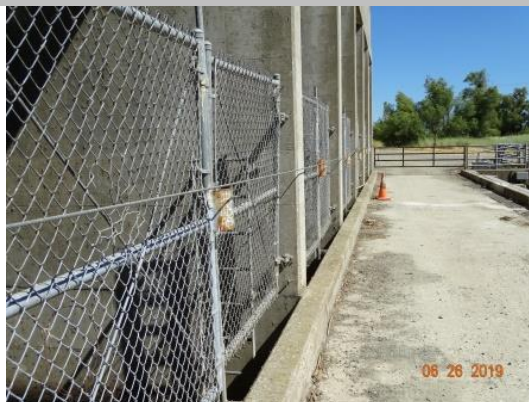
Photo 4 of 7 : ST\_2019\_NA0060\_22\_5\_20190627\_00051.jpg

View of fall protection cable next to wet wells (Summer 2019).

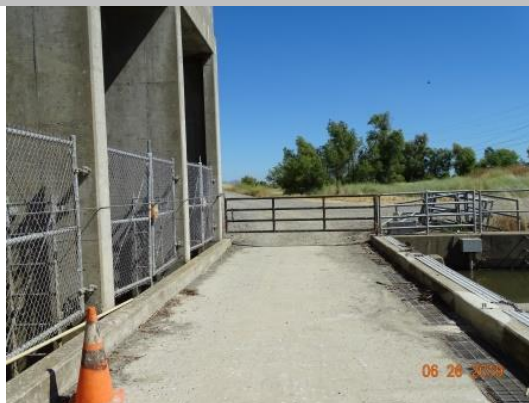
Photo 5 of 7 : ST\_2019\_NA0060\_22\_5\_20190627\_00052.jpg

View of gate closing off access to pump inlet (Summer 2019).

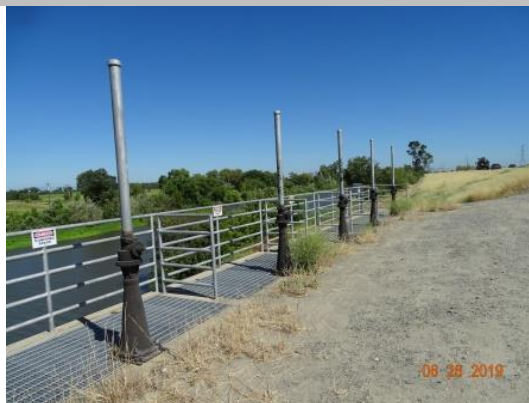
Photo 6 of 7 : ST\_2019\_NA0060\_22\_5\_20190627\_00053.jpg

View of railing and signage next to manual gate operators (Summer 2019).

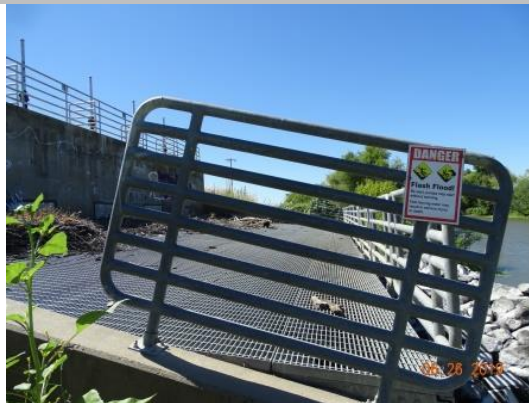
Photo 7 of 7 : ST\_2019\_NA0060\_22\_5\_20190627\_00054.jpg

View of railings and signage above flap gates (Summer 2019).

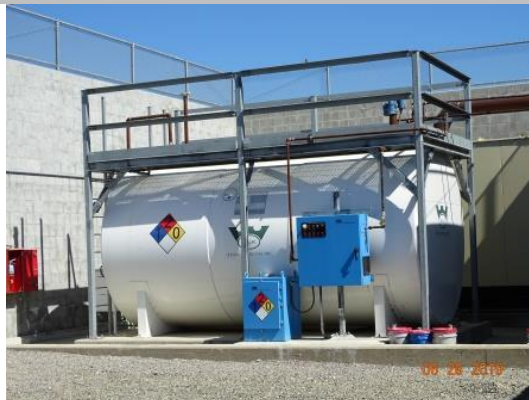
Photo 1 of 2 : ST\_2019\_NA0060\_22\_8\_20190627\_00055.jpg

LM Start	0.00	Rating **	A	Issue No.	8	
LM End	0.00	Issue Type +	Ma	Location *		
Category	Pump Stations			GPS Latitude/Longitude		
				Start	End	
Item	Power			39.026449 °	39.026449 °	
				-121.726937 °	-121.726937 °	
DWR ID	DWR_NA0060_22_t_2012_8					
Action/Comments						
Inspector Comments: The structure is on the grid with emergency backup generator.

View fuel tank for emergency generator (Summer 2019).

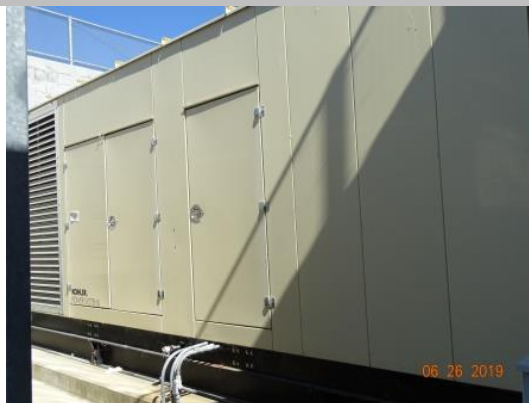
Photo 2 of 2 : ST\_2019\_NA0060\_22\_8\_20190627\_00056.jpg

View of emergency generator (Summer 2019).

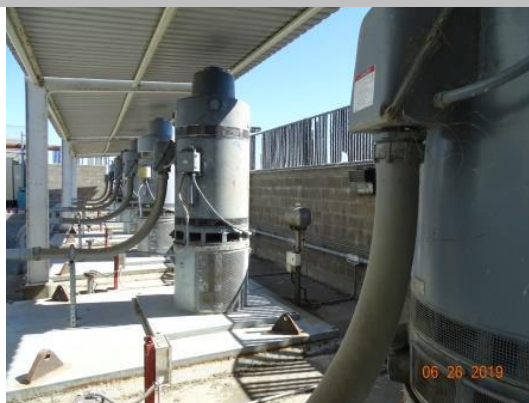
Photo 1 of 2 : ST\_2019\_NA0060\_22\_10\_20190627\_00057.jpg

LM Start	0.00	Rating **	A	Issue No.	10
LM End	0.00	Issue Type +	Ma	Location *	
Category	Pump Stations			GPS Latitude/Longitude	
				Start	End
Item	Motors, Engines, Fans & Gear Reducers			39.026449 °	39.026449 °
				-121.726937 °	-121.726937 °
DWR ID	DWR_NA0060_22_t_2012_10				
Action/Comments					
Inspector Comments: These items appear to be maintained and in operational condition.

View of pump motors (Summer 2019).

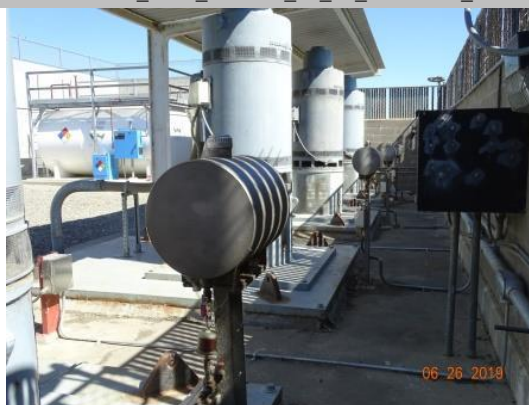
Photo 2 of 2 : ST\_2019\_NA0060\_22\_10\_20190627\_00058.jpg

View of pump oil wells (Summer 2019).

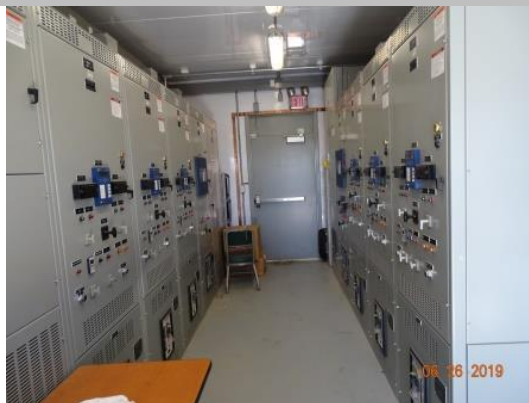
Photo 1 of 1 : ST\_2019\_NA0060\_22\_11\_20190627\_00059.jpg

LM Start	0.00	Rating **	A	Issue No.	11
LM End	0.00	Issue Type +	Ma	Location *	
Category	Pump Stations			GPS Latitude/Longitude	
				Start	End
Item	Pump Control Systems			39.026449 °	39.026449 °
				-121.726937 °	-121.726937 °
DWR ID	DWR_NA0060_22_t_2012_11				
Action/Comments					
Inspector Comments: Pump control systems on site are new and appear to be in working order.

View of pump control panels in operating building (Summer 2019).

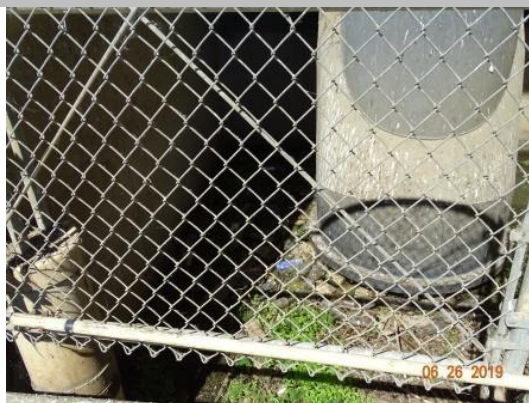
Photo 1 of 1 : ST\_2019\_NA0060\_22\_12\_20190627\_00060.jpg

LM Start	0.00	Rating **	M	Issue No.	12
LM End	0.00	Issue Type +	Ma	Location *	
Category	Pump Stations			GPS Latitude/Longitude	
				Start	End
Item	Sumps/Wet Well			39.026449 °	39.026449 °
				-121.726937 °	-121.726937 °
DWR ID	DWR_NA0060_22_t_2012_12				
Action/Comments					
Inspector Comments: Trash and plant debris buildup in sump number 4 should be removed.

View of debris in sump 4 (Summer 2019).

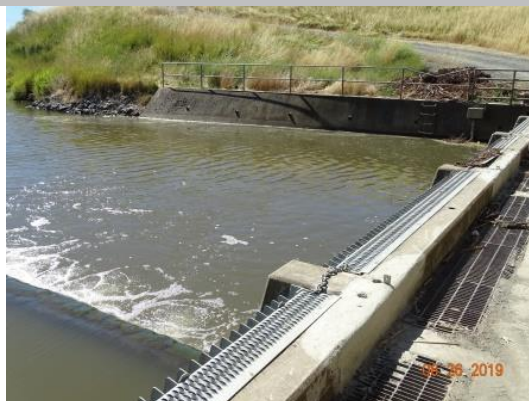
Photo 1 of 1 : ST\_2019\_NA0060\_22\_13\_20190627\_00061.jpg

LM Start	0.00	Rating **	A	Issue No.	13
LM End	0.00	Issue Type +	Ma	Location *	
Category	Pump Stations			GPS Latitude/Longitude	
				Start	End
Item	Trash Racks			39.026449 °	39.026449 °
				-121.726937 °	-121.726937 °
DWR ID	DWR_NA0060_22_t_2012_13				
Action/Comments					
Inspector Comments: Trash rack is secure and free of debris.

View of trash racks (Summer 2019).

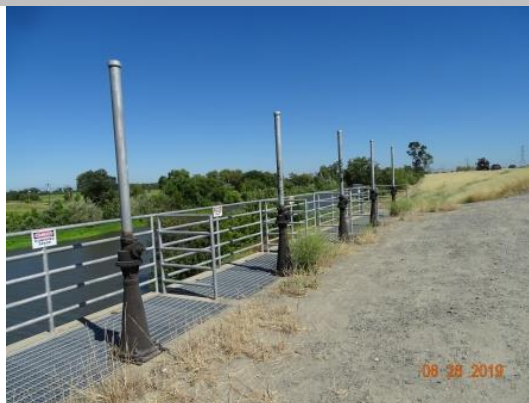
Photo 1 of 1 : ST\_2019\_NA0060\_22\_17\_20190627\_00062.jpg

LM Start	0.00	Rating **	A	Issue No.	17
LM End	0.00	Issue Type +	Ma	Location *	
Category	Pump Stations			GPS Latitude/Longitude	
				Start	End
Item	Manual Gate Operators			39.026449 °	39.026449 °
				-121.726937 °	-121.726937 °
DWR ID	DWR_NA0060_22_t_2012_17				
Action/Comments					
Inspector Comments: Manual gate operators appear to be in good working condition.

View of manual gate operators (Summer 2019).

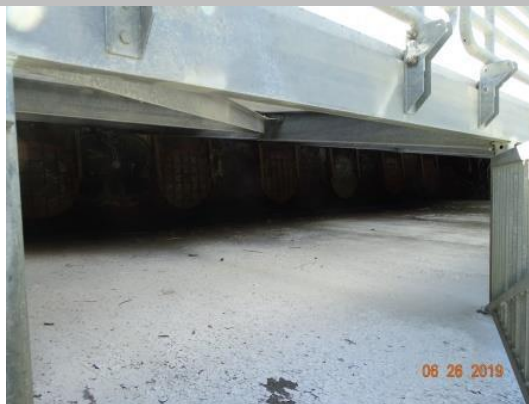
Photo 1 of 1 : ST\_2019\_NA0060\_22\_19\_20190627\_00063.jpg

LM Start	0.00	Rating **	A	Issue No.	19
LM End	0.00	Issue Type +	Ma	Location *	
Category	Pump Stations			GPS Latitude/Longitude	
				Start	End
Item	Flap Gates			39.026449 °	39.026449 °
				-121.726937 °	-121.726937 °
DWR ID	DWR_NA0060_22_t_2019_19				
Action/Comments					
Inspector Comments: Flap gates appear to be in working condition. There are no apparent signs of significant corrosion or damage. All are closed.

View of closed flap gates (Summer 2019).

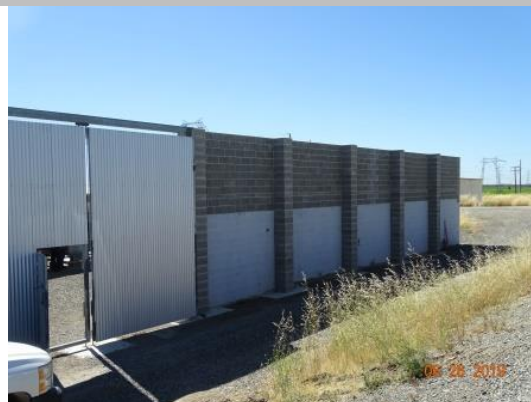
Photo 1 of 1 : ST\_2019\_NA0060\_22\_21\_20190627\_00064.jpg

LM Start	0.00	Rating **	A	Issue No.	21
LM End	0.00	Issue Type +	Ma	Location *	
Category	Pump Stations			GPS Latitude/Longitude	
				Start	End
Item	Security Fencing			39.026449 °	39.026449 °
				-121.726937 °	-121.726937 °
DWR ID	DWR_NA0060_22_t_2012_21				
Action/Comments					
Inspector Comments: Site is secured with masonry and concrete wall and steel entrance door.

View of steel security door and concrete security wall around facility (Summer 2019).

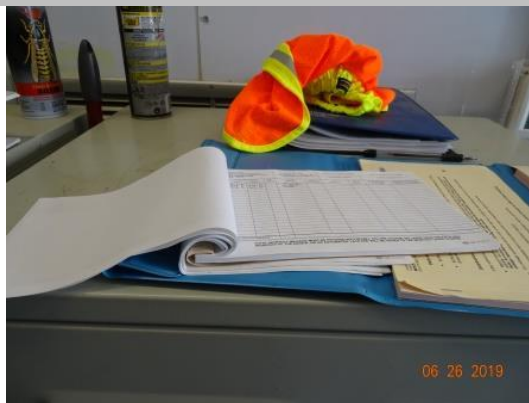
Photo 1 of 1 : ST\_2019\_NA0060\_23\_1\_20190627\_00025.jpg

LM Start	0.00	Rating **	A	Issue No.	1
LM End	0.00	Issue Type +	Ma	Location *	
Category	Pump Stations			GPS Latitude/Longitude	
				Start	End
Item	Operating Log			39.120096 °	39.120096 °
				-121.779234 °	-121.779234 °
DWR ID	DWR_NA0060_23_t_2012_1				
Action/Comments					
Inspector Comments: Operation log is at the site.

View of operating log (Summer 2019).

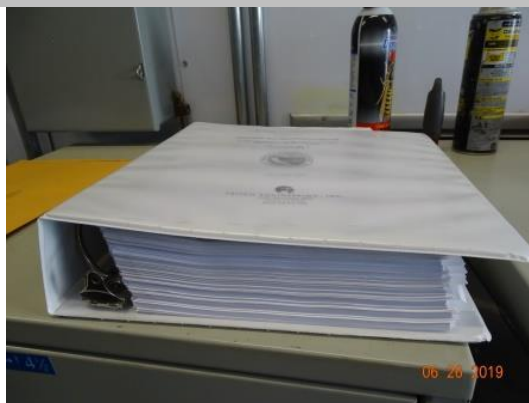
Photo 1 of 1 : ST\_2019\_NA0060\_23\_2\_20190627\_00024.jpg

LM Start	0.00	Rating **	A	Issue No.	2
LM End	0.00	Issue Type +	Ma	Location *	
Category	Pump Stations			GPS Latitude/Longitude	
				Start	End
Item	Operation & Maintenance Manual			39.120096 °	39.120096 °
				-121.779230 °	-121.779230 °
DWR ID	DWR_NA0060_23_t_2012_2				
Action/Comments					
Inspector Comments: O&M Manual is present at the site. Sutter Maintenance Yard will provide documentation of maintenance going forward.

View of O&amp;M Manual (Summer 2019).

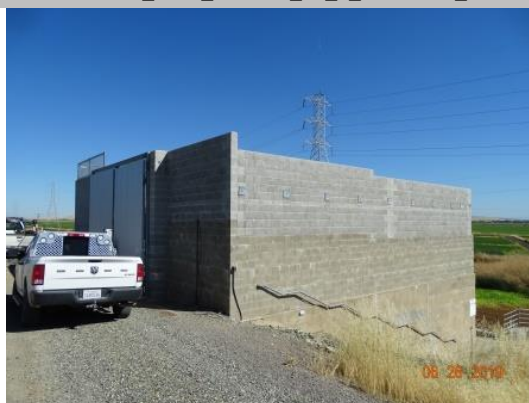
Photo 1 of 1 : ST\_2019\_NA0060\_23\_3\_20190627\_00026.jpg

LM Start	0.00	Rating **	A	Issue No.	3
LM End	0.00	Issue Type +	Ma	Location *	
Category	Pump Stations			GPS Latitude/Longitude	
				Start	End
Item	Plant Building			39.120096 °	39.120096 °
				-121.779230 °	-121.779230 °
DWR ID	DWR_NA0060_23_t_2012_3				
Action/Comments					
Inspector Comments: Plant building appears to be in working condition.

View of outside of plant building (Summer 2019).

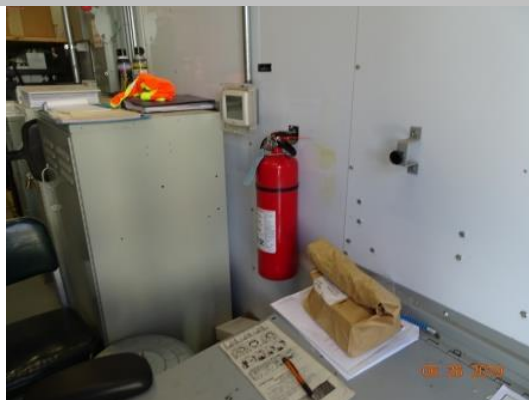
Photo 1 of 7 : ST\_2019\_NA0060\_23\_5\_20190627\_00027.jpg

LM Start	0.00	Rating **	A	Issue No.	5	
LM End	0.00	Issue Type +	Ma	Location *		
Category	Pump Stations			GPS Latitude/Longitude		
				Start	End	
Item	Safety			39.120096 °	39.120096 °	
				-121.779230 °	-121.779230 °	
DWR ID	DWR_NA0060_23_t_2012_5					
Action/Comments						
Inspector Comments: The site has fire extinguishers on site and fall protection rails.

View of fire extinguisher inside operating building (Summer 2019).

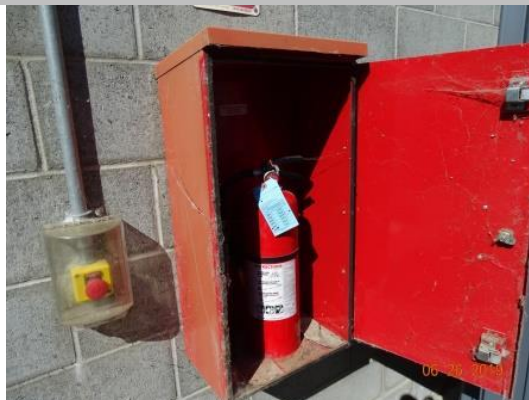
Photo 2 of 7 : ST\_2019\_NA0060\_23\_5\_20190627\_00028.jpg

View of fire extinguisher adjacent to facility entrance (Summer 2019).

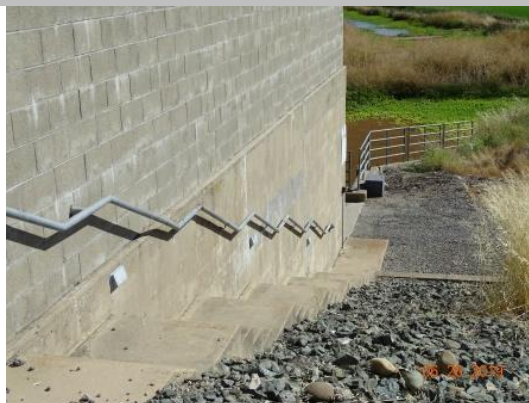
Photo 3 of 7 : ST\_2019\_NA0060\_23\_5\_20190627\_00029.jpg

LM Start	0.00	Rating **	A	Issue No.	5 (cont)	
LM End	0.00	Issue Type +	Ma	Location *		
Category	Pump Stations			GPS Latitude/Longitude		
				Start	End	
Item	Safety			39.120096 °	39.120096 °	
				-121.779230 °	-121.779230 °	
DWR ID	DWR_NA0060_23_t_2012_5					
Action/Comments						
Inspector Comments: The site has fire extinguishers on site and fall protection rails.

View of railing for stairway down to pump inlet (Summer 2019).

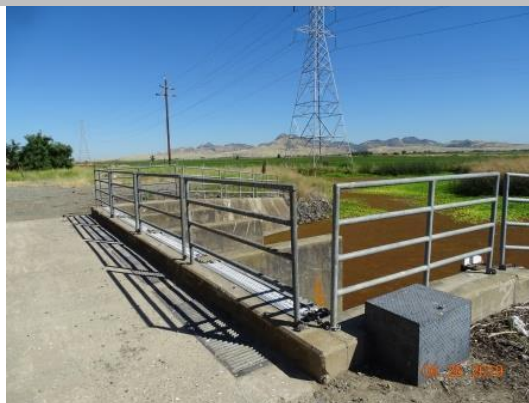
Photo 4 of 7 : ST\_2019\_NA0060\_23\_5\_20190627\_00030.jpg

View of railings next to pump inlet (Summer 2019).

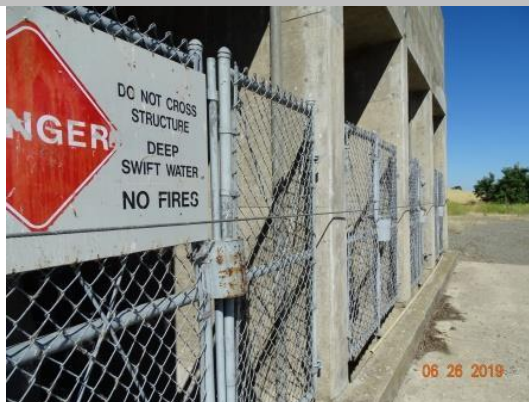
Photo 5 of 7 : ST\_2019\_NA0060\_23\_5\_20190627\_00031.jpg

View of fall protection cable and signage on next to wet wells (Summer 2019).

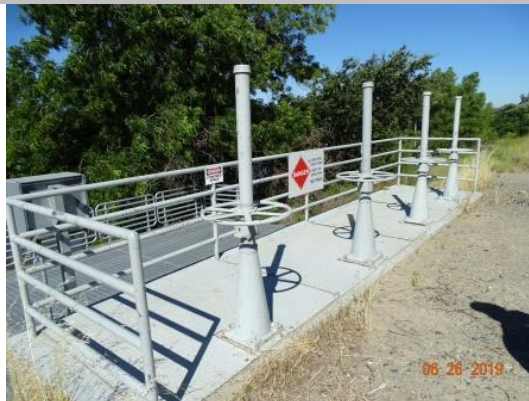
Photo 6 of 7 : ST\_2019\_NA0060\_23\_5\_20190627\_00032.jpg

LM Start	0.00	Rating **	A	Issue No.	5 (cont)	
LM End	0.00	Issue Type +	Ma	Location *		
Category	Pump Stations			GPS Latitude/Longitude		
				Start	End	
Item	Safety			39.120096 °	39.120096 °	
				-121.779230 °	-121.779230 °	
DWR ID	DWR_NA0060_23_t_2012_5					
Action/Comments						
Inspector Comments: The site has fire extinguishers on site and fall protection rails.

View of safety railing and signage next to manual gate operators (Summer 2019).

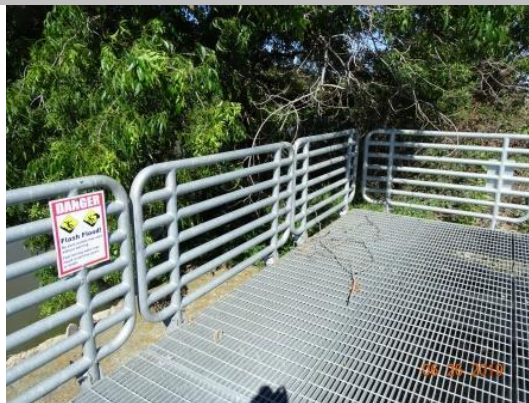
Photo 7 of 7 : ST\_2019\_NA0060\_23\_5\_20190627\_00033.jpg

View of safety railing and signage above flap gates (Summer 2019).

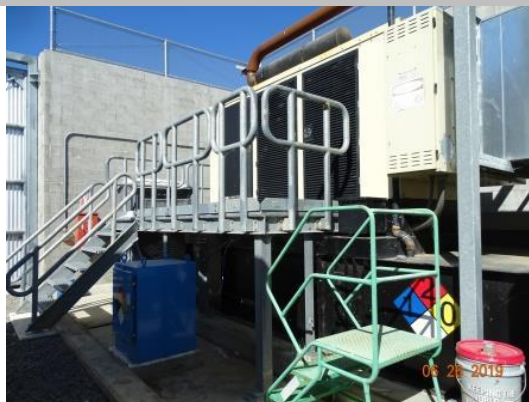
Photo 1 of 1 : ST\_2019\_NA0060\_23\_8\_20190627\_00034.jpg

LM Start	0.00	Rating **	A	Issue No.	8	
LM End	0.00	Issue Type +	Ma	Location *		
Category	Pump Stations			GPS Latitude/Longitude		
				Start	End	
Item	Power			39.120096 °	39.120096 °	
				-121.779230 °	-121.779230 °	
DWR ID	DWR_NA0060_23_t_2012_8					
Action/Comments						
Inspector Comments: The structure is on the grid with emergency generator backup.

View of emergency backup generator (Summer 2019).

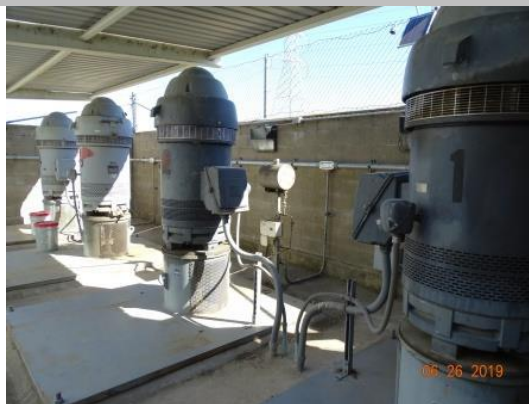
Photo 1 of 2 : ST\_2019\_NA0060\_23\_10\_20190627\_00035.jpg

LM Start	0.00	Rating **	A	Issue No.	10
LM End	0.00	Issue Type +	Ma	Location *	
Category	Pump Stations			GPS Latitude/Longitude	
				Start	End
Item	Motors, Engines, Fans & Gear Reducers			39.120096 °	39.120096 °
				-121.779230 °	-121.779230 °
DWR ID	DWR_NA0060_23_t_2012_10				
Action/Comments					
Inspector Comments: These items appear to be maintained and in operating condition.

View of pump motors (Summer 2019).

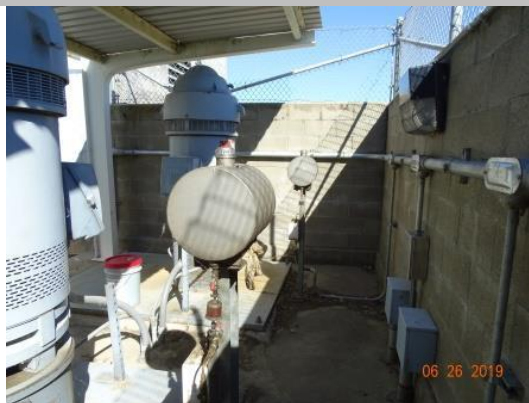
Photo 2 of 2 : ST\_2019\_NA0060\_23\_10\_20190627\_00036.jpg

LM Start	0.00	Rating **	A	Issue No.	10 (cont)	
LM End	0.00	Issue Type +	Ma	Location *		
Category	Pump Stations			GPS Latitude/Longitude		
				Start	End	
Item	Motors, Engines, Fans & Gear Reducers			39.120096 °	39.120096 °	
				-121.779230 °	-121.779230 °	
DWR ID	DWR_NA0060_23_t_2012_10					
Action/Comments						
Inspector Comments: These items appear to be maintained and in operating condition.

View of pump oil well (Summer 2019).

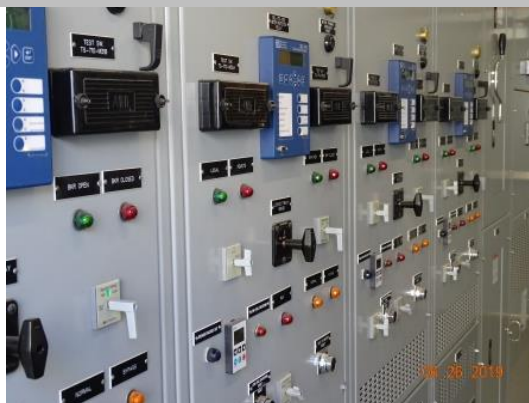
Photo 1 of 1 : ST\_2019\_NA0060\_23\_11\_20190627\_00037.jpg

LM Start	0.00	Rating **	A	Issue No.	11
LM End	0.00	Issue Type +	Ma	Location *	
Category	Pump Stations			GPS Latitude/Longitude	
				Start	End
Item	Pump Control Systems			39.120096 °	39.120096 °
				-121.779230 °	-121.779230 °
DWR ID	DWR_NA0060_23_t_2012_11				
Action/Comments					
Inspector Comments: Pump control systems on site are new and appear to be in working order.

View of pump control panels in operating building (Summer 2019).

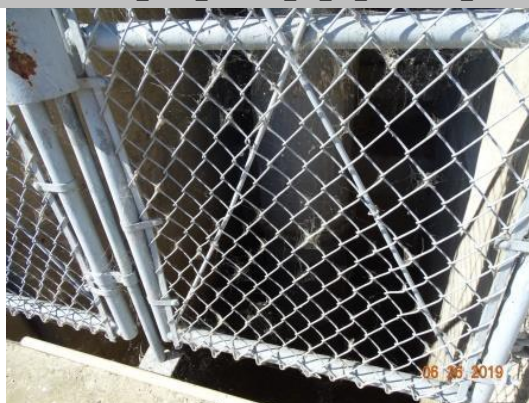
Photo 1 of 1 : ST\_2019\_NA0060\_23\_12\_20190627\_00039.jpg

LM Start	0.00	Rating **	A	Issue No.	12	
LM End	0.00	Issue Type +	Ma	Location *		
Category	Pump Stations			GPS Latitude/Longitude		
				Start	End	
Item	Sumps/Wet Well			39.120096 °	39.120096 °	
				-121.779230 °	-121.779230 °	
DWR ID	DWR_NA0060_23_t_2012_12					
Action/Comments						
Inspector Comments: Sumps are clear and free of debris.

View of one wet well that represents appearance of all wet wells (Summer 2019).

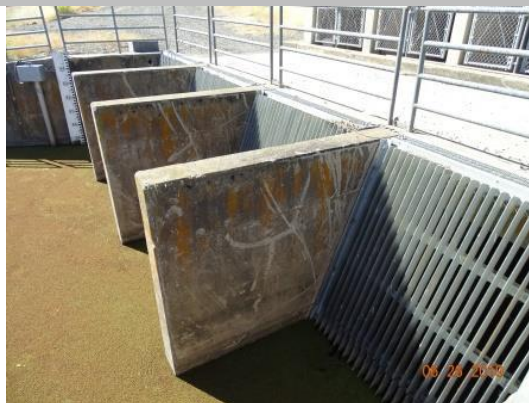
Photo 1 of 1 : ST\_2019\_NA0060\_23\_13\_20190627\_00038.jpg

LM Start	0.00	Rating **	A	Issue No.	13
LM End	0.00	Issue Type +	Ma	Location *	
Category	Pump Stations			GPS Latitude/Longitude	
				Start	End
Item	Trash Racks			39.120096 °	39.120096 °
				-121.779230 °	-121.779230 °
DWR ID	DWR_NA0060_23_t_2012_13				
Action/Comments					
Inspector Comments: No debris present on trash racks, they appear to be in good condition.

View of trash racks (Summer 2019).

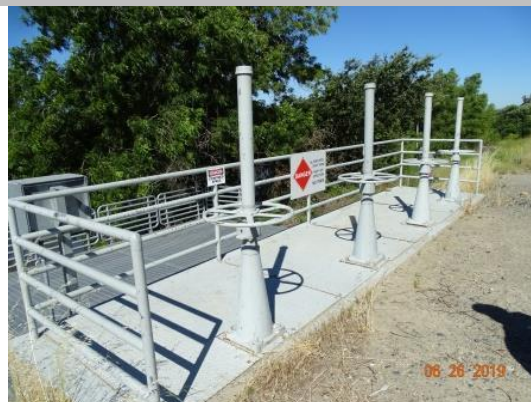
Photo 1 of 1 : ST\_2019\_NA0060\_23\_17\_20190627\_00040.jpg

LM Start	0.00	Rating **	A	Issue No.	17	
LM End	0.00	Issue Type +	Ma	Location *		
Category	Pump Stations			GPS Latitude/Longitude		
				Start	End	
Item	Manual Gate Operators			39.120096 °	39.120096 °	
				-121.779230 °	-121.779230 °	
DWR ID	DWR_NA0060_23_t_2012_17					
Action/Comments						
Inspector Comments: Manual gate operators appear to be in working order.

View of manual gate operators (Summer 2019).

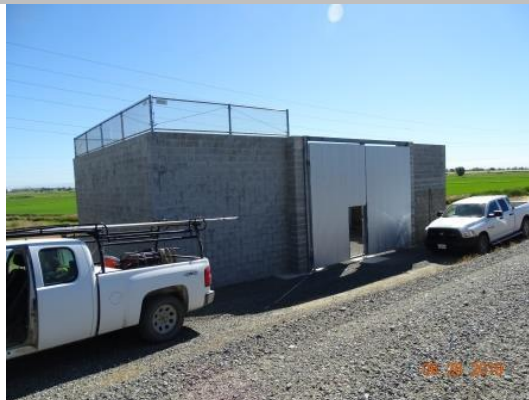
Photo 1 of 1 : ST\_2019\_NA0060\_23\_21\_20190627\_00041.jpg

LM Start	0.00	Rating **	A	Issue No.	21
LM End	0.00	Issue Type +	Ma	Location *	
Category	Pump Stations			GPS Latitude/Longitude	
				Start	End
Item	Security Fencing			39.120096 °	39.120096 °
				-121.779230 °	-121.779230 °
DWR ID	DWR_NA0060_23_t_2012_21				
Action/Comments					
Inspector Comments: Site is currently secured by a concrete wall and steel entrance door.

View of concrete security fencing and steel entrance door (Summer 2019).

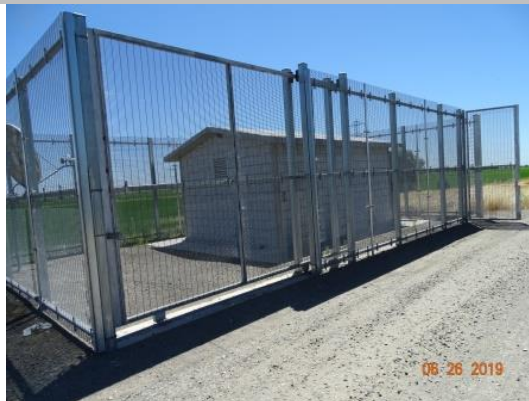
Photo 1 of 4 : ST\_2019\_NA0060\_10\_1\_20190627\_00019.jpg

LM Start	0.00	Rating **	N	Issue No.	1
LM End	0.00	Issue Type +	Ma	Location *	
Category	Structures & Concrete Lined Channels			GPS Latitude/Longitude	
				Start	End
Item	Photo Documentation			39.102526°	39.102526°
				-121.758682°	-121.758682°
DWR ID	DWR_NA0060_10_t_2012_1				
Action/Comments					
Inspector Comments: The new weir is built under the Permit No. 18400 (CVFPB) issued 10-30-2008.

View of outside of compressor facility (Summer 2019).

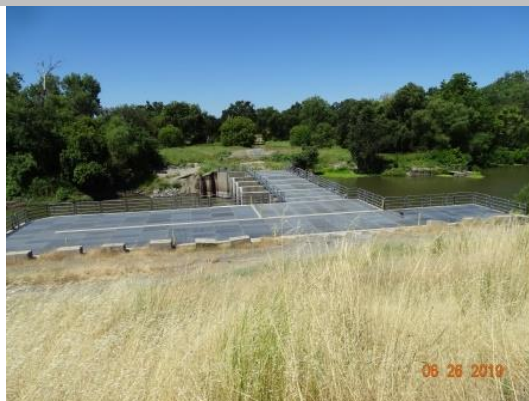
Photo 2 of 4 : ST\_2019\_NA0060\_10\_1\_20190627\_00016.jpg

View looking downslope of levee at entire weir and fish ladder (Summer 2019).

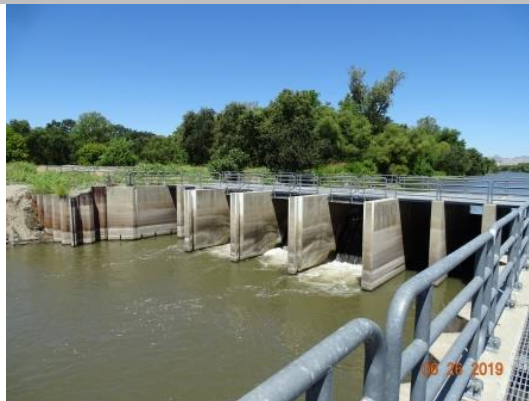
Photo 3 of 4 : ST\_2019\_NA0060\_10\_1\_20190627\_00017.jpg

View looking upstream at weir (Summer 2019).

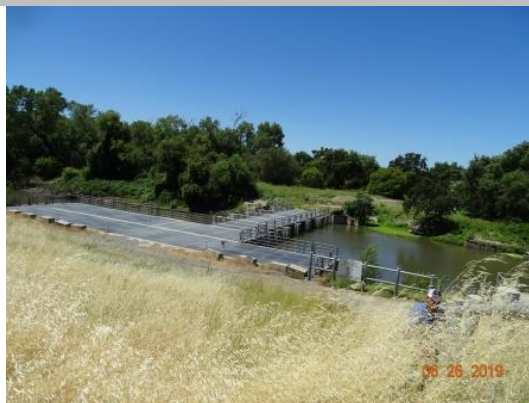
Photo 4 of 4 : ST\_2019\_NA0060\_10\_1\_20190627\_00018.jpg

View looking downslope and slightly downstream at weir and fish ladder (Summer 2019).

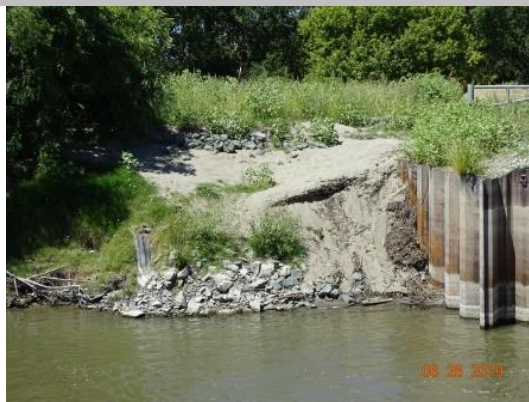
Photo 1 of 2 : ST\_2019\_NA0060\_10\_5\_20190627\_00020.jpg

LM Start	0.00	Rating **	A	Issue No.	5
LM End	0.00	Issue Type +	Ma	Location *	
Category	Structures & Concrete Lined Channels			GPS Latitude/Longitude	
				Start	End
Item	Revetments			39.102526 °	39.102526 °
				-121.758682 °	-121.758682 °
DWR ID	DWR_NA0060_10_t_2012_5				
Action/Comments					
Inspector Comments: Existing riprap protection is properly maintained and is undamaged. Riprap clearly visible.

View of riprap on the rightbank downstream of the weir (Summer 2019).

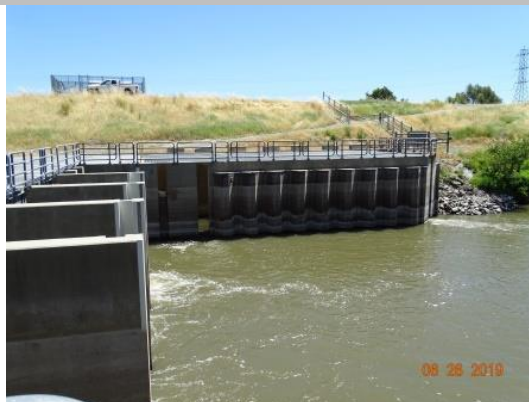
Photo 2 of 2 : ST\_2019\_NA0060\_10\_5\_20190627\_00021.jpg

View of rip rap on the leftbank downstream of the weir (Summer 2019).

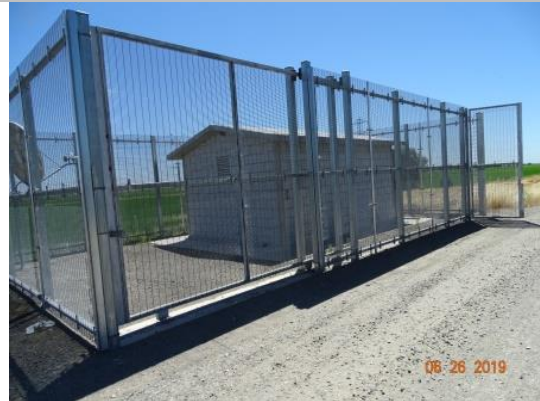
Photo 1 of 1 : ST\_2019\_NA0060\_10\_18\_20190627\_00022.jpg

LM Start	0.00	Rating **	A	Issue No.	18
LM End	0.00	Issue Type +	Ma	Location *	
Category	Structures & Concrete Lined Channels			GPS Latitude/Longitude	
				Start	End
Item	Security Fencing			39.102526 °	39.102526 °
				-121.758682 °	-121.758682 °
DWR ID	DWR_NA0060_10_t_2012_18				
Action/Comments					
Inspector Comments: Safety / security fencing is good condition and provides protection against falling or unauthorized access. Gates open and close freely, locks are in place, and there is little corrosion on metal parts. The fence is very close to the hing point of the slope and does not allow access around the out side of the fence in this location.

View of security fencing around the compressor building (Summer 2019).

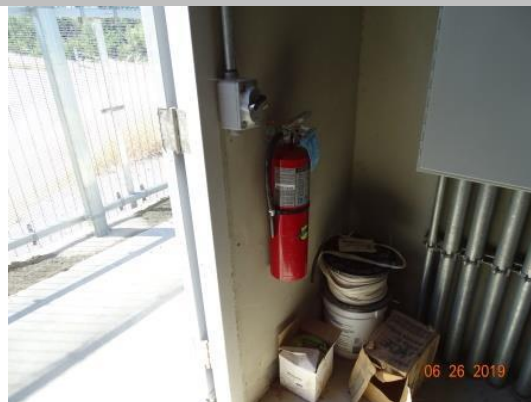
Photo 1 of 2 : ST\_2019\_NA0060\_10\_23\_20190627\_00023.jpg

LM Start	0.00	Rating **	A	Issue No.	23
LM End	0.00	Issue Type +	Ma	Location *	
Category	Structures & Concrete Lined Channels			GPS Latitude/Longitude	
				Start	End
Item	Safety			39.102526 °	39.102526 °
				-121.758682 °	-121.758682 °
DWR ID	DWR_NA0060_10_t_2012_23				
Action/Comments					
Inspector Comments: Safety hardware installed. Adequate protection for fall hazards exist. No hazardous conditions that might affect the operation of the structure. Fire extinguisher is located in in the compressor building and is current.

View of fire extinguisher in compressor building (Summer 2019).

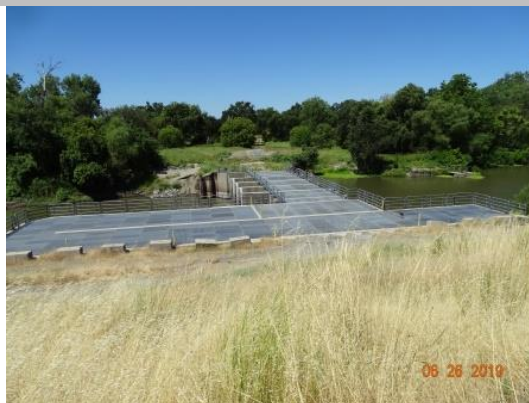
Photo 2 of 2 : ST\_2019\_NA0060\_10\_23\_20190627\_00024.jpg

LM Start	0.00	Rating **	A	Issue No.	23 (cont)	
LM End	0.00	Issue Type +	Ma	Location *		
Category	Structures & Concrete Lined Channels			GPS Latitude/Longitude		
				Start		End
Item	Safety			39.102526 °		39.102526 °
				-121.758682 °		-121.758682 °
DWR ID	DWR_NA0060_10_t_2012_23					
Action/Comments						
Inspector Comments: Safety hardware installed. Adequate protection for fall hazards exist. No hazardous conditions that might affect the operation of the structure. Fire extinguisher is located in in the compressor building and is current.

View of fall protection railing surrounding weir (Summer 2019).

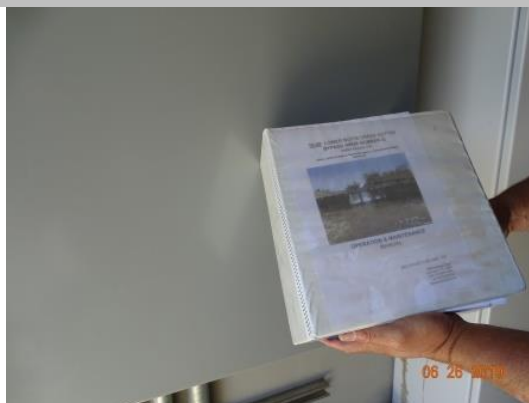
Photo 1 of 1 : ST\_2019\_NA0060\_10\_24\_20190627\_00025.jpg

LM Start	0.00	Rating **	A	Issue No.	24
LM End	0.00	Issue Type +	Ma	Location *	
Category	Structures & Concrete Lined Channels	GPS Latitude/Longitude			
		Start		End	
Item	Operation & Maintenance Manual	39.102526 °		39.102526 °	
		-121.758682 °		-121.758682 °	
DWR ID	DWR_NA0060_10_t_2013_24				
Action/Comments					
Inspector Comments: Sutter Maintenance Yard has a copy of the O&M at the site.

View of O&M manual (Summer 2019).

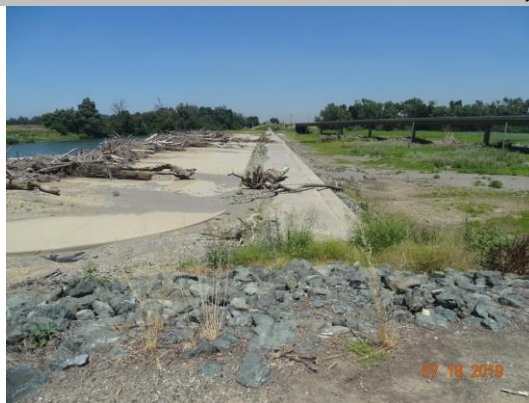
Photo 1 of 6 : ST\_2019\_NA0060\_3\_1\_20190719\_00021.jpg

View of weir from the downstream end of the Sacramento River. Summer 2019.

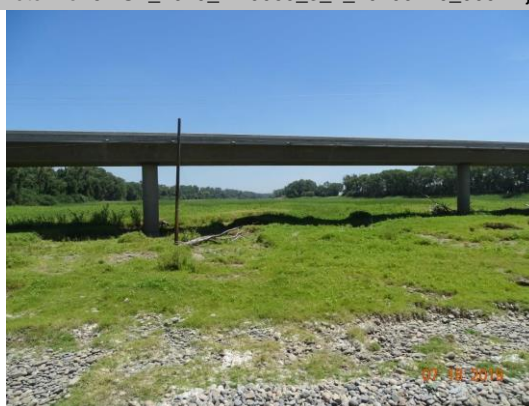
Photo 2 of 6 : ST\_2019\_NA0060\_3\_1\_20190719\_00022.jpg

View of Tisdale Bypass, facing downstream. Summer 2019.

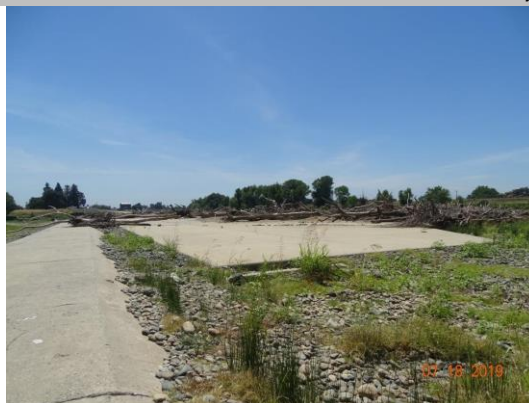
Photo 3 of 6 : ST\_2019\_NA0060\_3\_1\_20190719\_00023.jpg

View of adjacent parking lot and boat launch. Summer 2019.

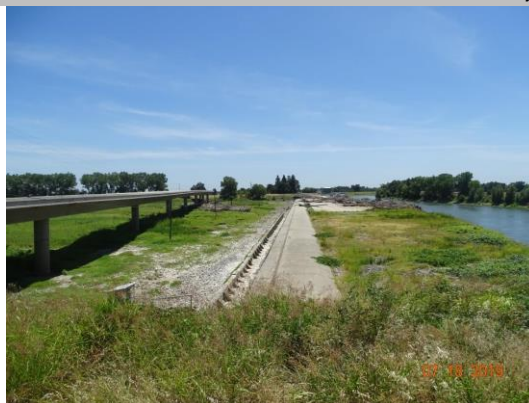
Photo 4 of 6 : ST\_2019\_NA0060\_3\_1\_20190719\_00024.jpg

View of weir from the upstream end of the Sacramento River. Summer 2019.

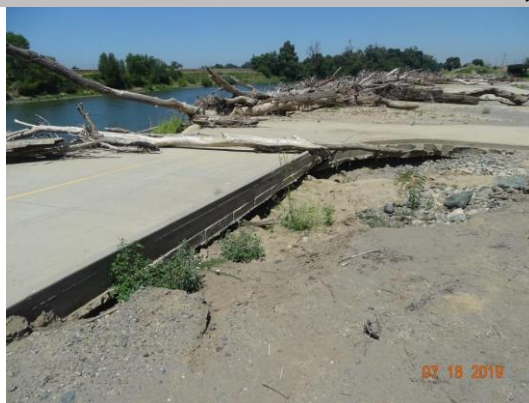
Photo 5 of 6 : ST\_2019\_NA0060\_3\_1\_20190723\_00034.jpg

View of eroded access ramp. Summer 2019.

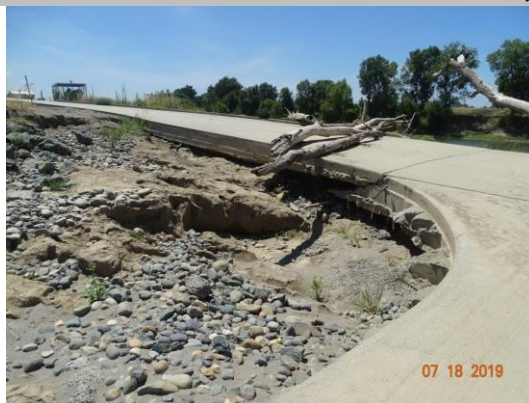
Photo 6 of 6 : ST\_2019\_NA0060\_3\_1\_20190723\_00035.jpg

Additional view of eroded access ramp. Summer 2019.

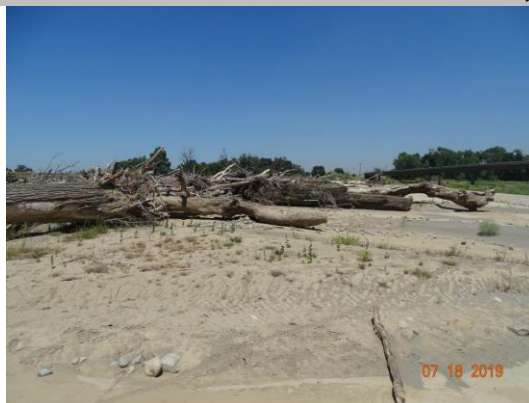
Photo 1 of 2 : ST\_2019\_NA0060\_3\_2\_20190719\_00025.jpg

LM Start	0.00	Rating **	U	Issue No.	2
LM End	0.00	Issue Type +	Ma	Location *	
Category	Structures & Concrete Lined Channels			GPS Latitude/Longitude	
				Start	End
Item	Vegetation & Obstructions			39.026713 °	39.026713 °
				-121.821995 °	-121.821995 °
DWR ID	DWR_NA0060_3_t_2012_2				
Action/Comments					
Inspector Comments: Significant amounts of tree trunks have settled on the boat launch parking area at the weir inlet.

View of dead trees at the weir inlet. Summer 2019.

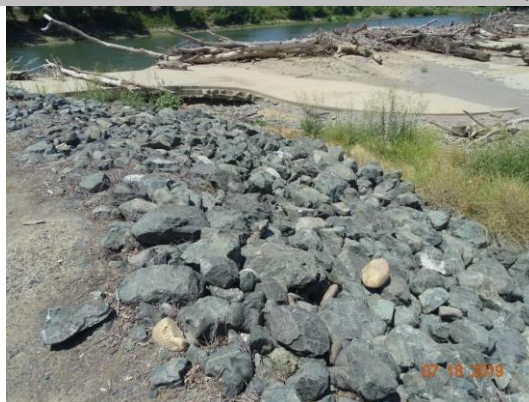
Photo 1 of 1 : ST\_2019\_NA0060\_3\_5\_20190722\_00027.jpg

LM Start	0.00	Rating **	A	Issue No.	5
LM End	0.00	Issue Type +	Ma	Location *	
Category	Structures & Concrete Lined Channels			GPS Latitude/Longitude	
				Start	End
Item	Revetments			39.026713 °	39.026713 °
				-121.821995 °	-121.821995 °
DWR ID	DWR_NA0060_3_t_2012_5				
Action/Comments					
Inspector Comments: Existing riprap is undamaged.

View of riprap on the south abutment. Summer 2019.

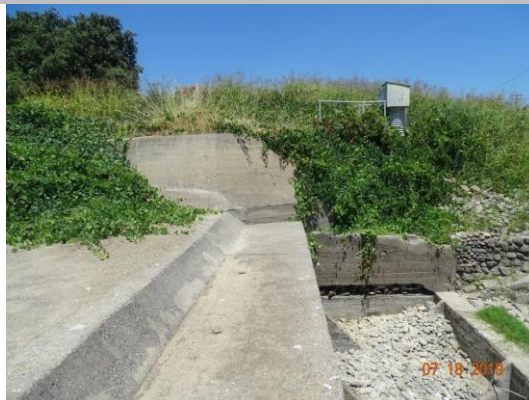
Photo 4 of 4 : ST\_2019\_NA0060\_3\_15\_20190722\_00032.jpg

LM Start	0.00	Rating **	U	Issue No.	15 (cont)	
LM End	0.00	Issue Type +	Ma	Location *		
Category	Structures & Concrete Lined Channels			GPS Latitude/Longitude		
				Start		End
Item	Concrete Surfaces			39.026713 °		39.026713 °
				-121.821995 °		-121.821995 °
DWR ID	DWR_NA0060_3_t_2012_15					
Action/Comments						
Inspector Comments: Spalling, scaling, cracking, exposed rebar throughout the structure.

View of north abutment. Summer 2019.

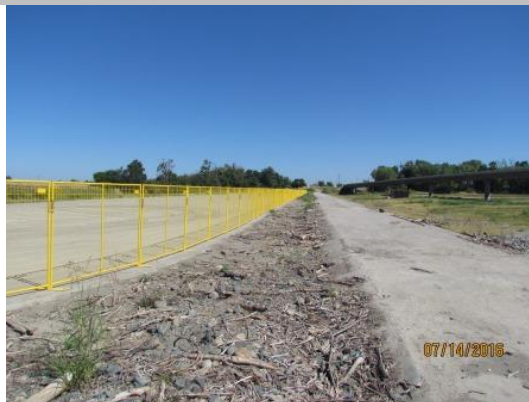
Photo 2 of 2 : ST\_2019\_NA0060\_3\_23\_20190625\_00020.jpg

View of safety fence separating the weir from the public parking lot in 2016.

LM Start	0.00	Rating **	M	Issue No.	23
LM End	0.00	Issue Type +	Ma	Location *	
Category	Structures & Concrete Lined Channels	GPS Latitude/Longitude			
		Start	End		
Item	Safety	39.026713 °		39.026713 °	
		-121.821995 °		-121.821995 °	
DWR ID	DWR_NA0060_3_t_2012_23				
Action/Comments					
Inspector Comments: Concrete should be repaired to conceal the exposed rebar. Safety fence is needed for protecting the structure from the public parking lot once the logs have been removed.

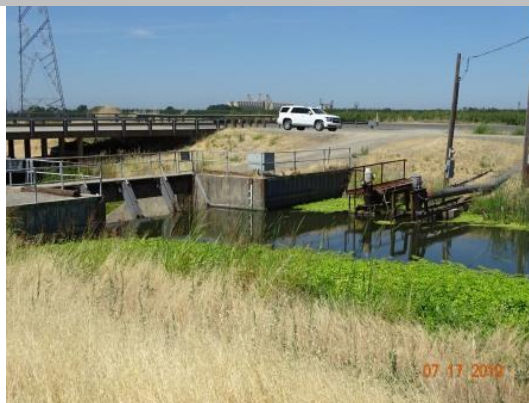
Photo 1 of 3 : ST\_2019\_NA0060\_11\_23\_20190718\_00004.jpg

View of the upstream side of the Wadsworth Canal Weir No. 4.

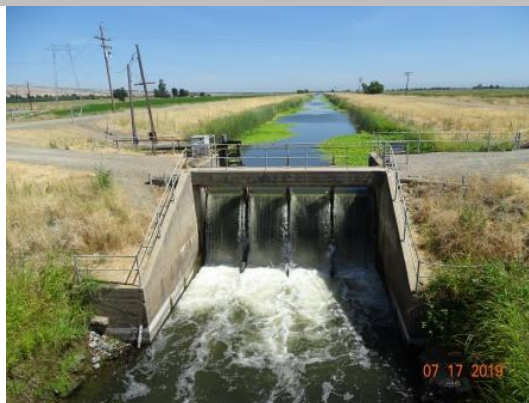
Photo 2 of 3 : ST\_2019\_NA0060\_11\_23\_20190718\_00005.jpg

View of the downstream side of the Wadsworth Canal Weir No. 4.

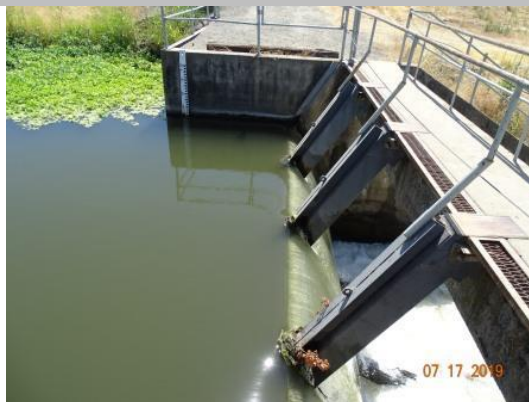
Photo 3 of 3 : ST\_2019\_NA0060\_11\_23\_20190718\_00006.jpg

Upclose view of the upstream side of the Wadsworth Canal Weir No. 4.

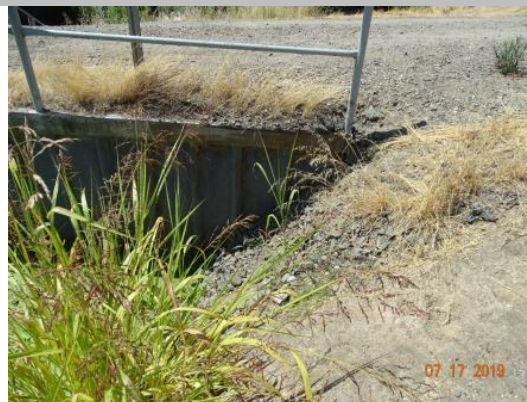
Photo 1 of 1 : ST\_2019\_NA0060\_11\_3\_20190718\_00007.jpg

View of the stabilized erosion site.
